# SoundWaves

VRPS Summer 2013

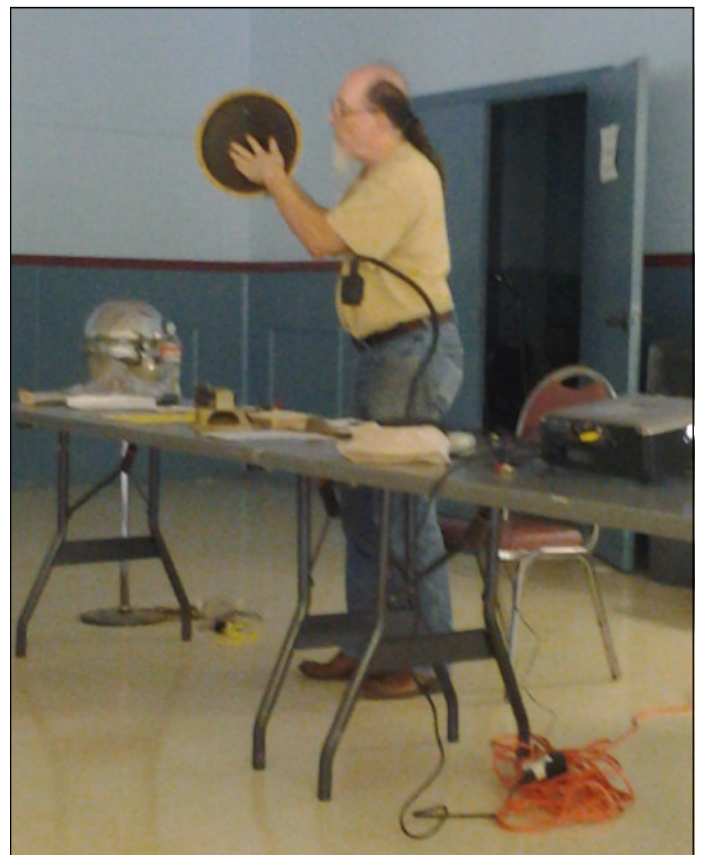
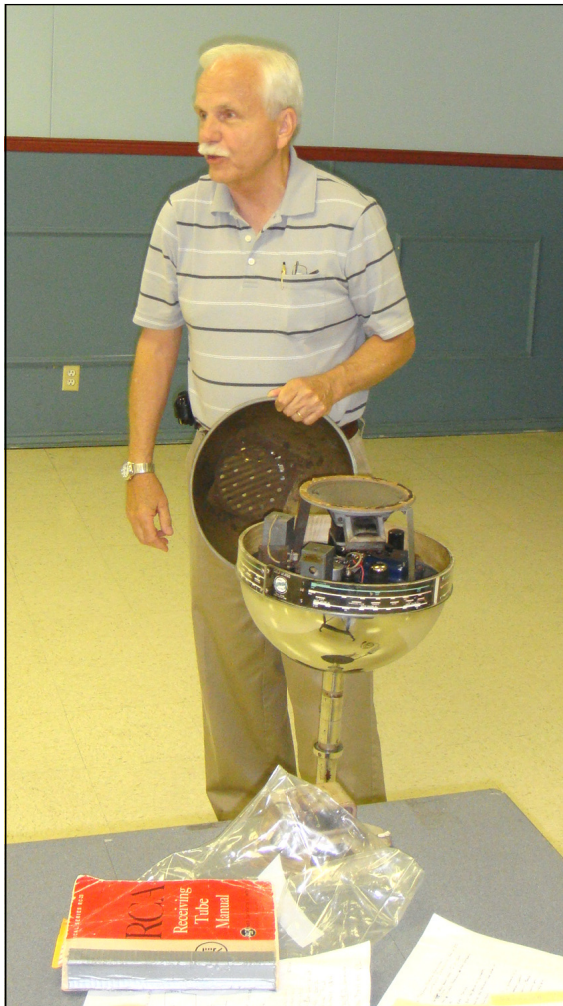
directly across the rectifier output. For these cases, a PM speaker can be substituted while the original field coil is simply disconnected. The power supply circuitry in the radio most often incorporates the field coil for its resistance and/or inductive properties. In some radios the field coil is connected directly across the rectifier output. Its resistance is relatively high. If used to repair another radio, a speaker of this type may need a resistor connected across it to duplicate the resistance of the original coil. Otherwise a series resistor can be added to make up for the new speaker having a lower resistance. If a permanent magnet speaker is used, a resistor will need to be used in place of the speaker field coil. In either case, to make up for the lack of an inductive element, the filter capacitor that connects to the end of the resistor opposite the one that connects to the rectifier tube will need to have its value increased by about 5 times (e.g. 40 instead of 8 mfd.). The capacitor at the rectifier should be about the same value as the original (more is not always better) so that, when the radio is turned off the filament-type rectifier tube will not get "flashed" by the reverse voltage sustained by the capacitor. In some older radio circuit designs the speaker field is connected in the return side of the

power supply, and the voltage developed across the coil is used as a negative bias source for the audio output tube. For these circuits, especially, the resistance of the field coil needs to be replicated using resistors, series or parallel, as needed, to get the same resistance as the original speaker. If no data is available as to the resistance, tube-manual operating data on the output tube can be used to calculate a useable value. Otherwise an experimental test value (e.g. 1000 ohms, 5 watts) can be tried and modified to make measurements of the bias voltage agree with the tube "operating conditions". For self-bias designs, the output tube bias voltage can be measured across the cathode resistor. Mike wrapped up his discussion with a review of measures needed to replace output transformers, including calculation of impedance matching values and transformer selection considerations.

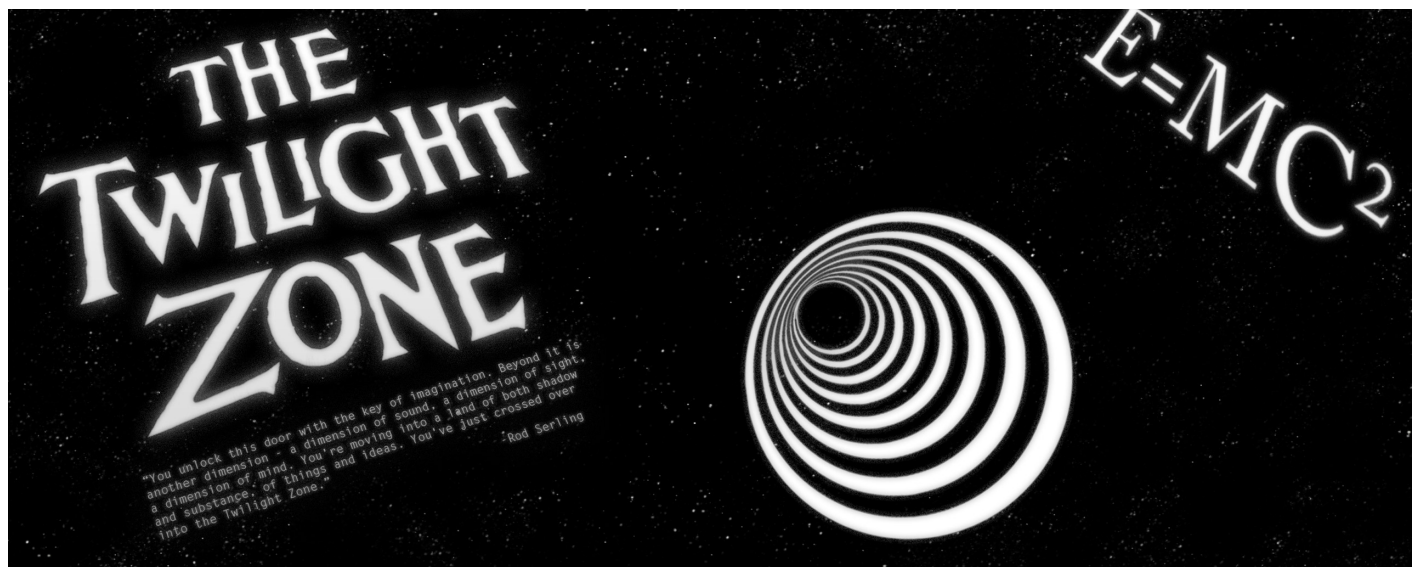
How could a signal on the cathode of an output tube across the chassis from the volume control be coming out of the slider on the volume control when both the other terminals on the volume control were verified shorted to ground, and had no signal on them?

Tune into the next issue of the Sound Waves for the solution of this seemingly impossible situation, or solve the mystery yourself!

Go to : <http://www.vrps.org/Repair.html> to see the partial schematics to aid you on your quest.

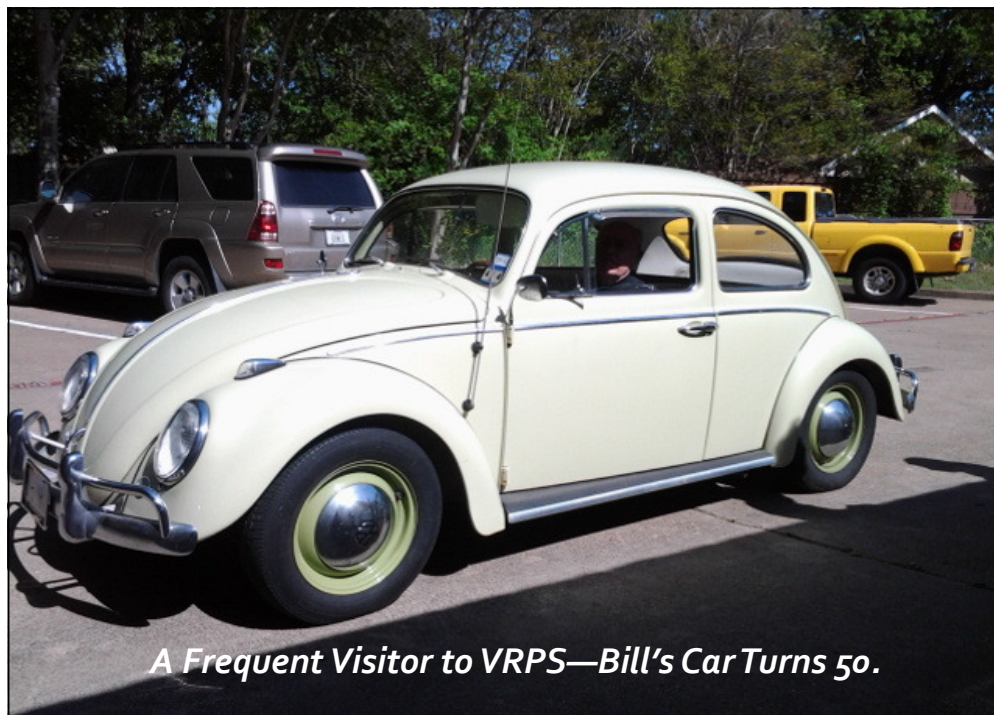
*A Frequent Visitor to VRPS—Bill's Car Turns 50.*

I bought it new 50 years ago, in April 1963, and until mid 2012 it was a daily driver - my "work car". It has actual miles of 184,000 and has been restored to look like new inside and out. As most people know, the VW factory did not install radios, but provided a mounting and grill for a 4 inch speaker and a removable panel in which to install a radio. Several radio manufacturers made radios that exactly fit the opening, with names such as Sapphire and Blaupunkt. A little known fact is that Motorola also made both a manually-tuned and a pushbutton model, with matching VW

trim. In 1964 I bought the manually-tuned model, which cost around \$64.00 - a lot of money in those days. It says "ALL TRANSISTOR" on the dial. I have kept this 6 volt radio working. It has 3 germanium transistors in the front end, two silicon transistors in the audio and a TO-3 germanium power output device- the ubiquitous 2N174. I had to repair the I.F. transformers by opening them up and removing the silvered mica caps and using 120pf NPo ceramics in their place.
