# SOUND WAVES

## VRPS Summer 2019

## The Case of the Worrisome Watterson

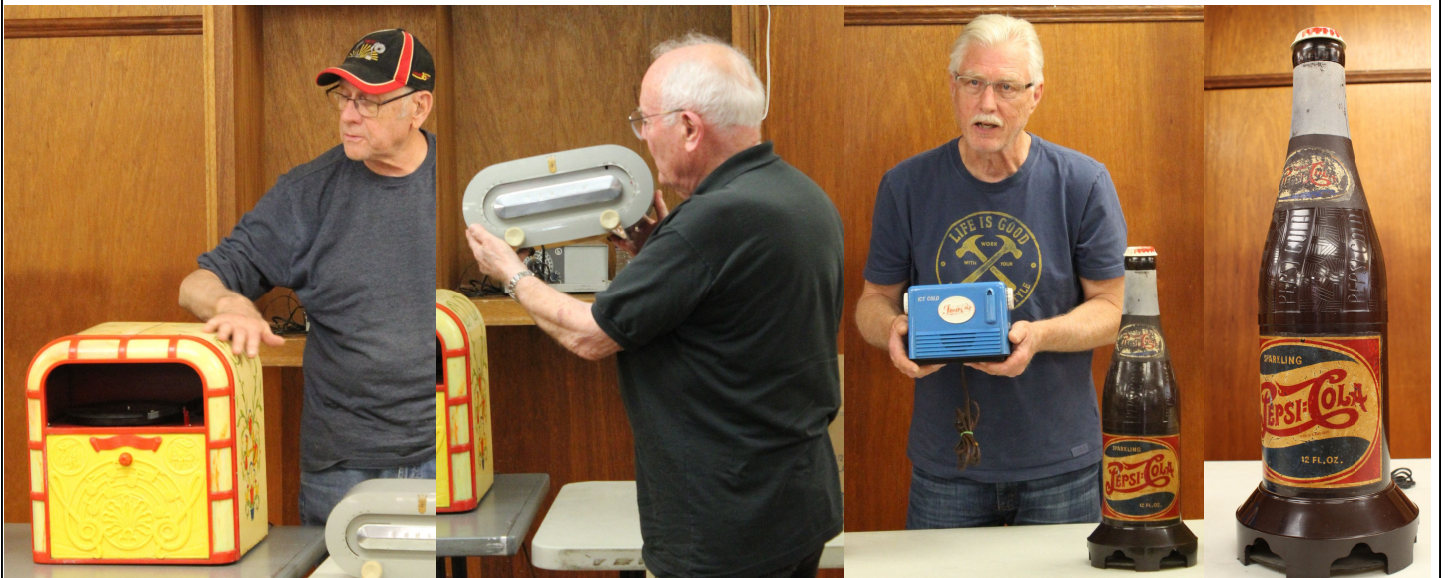
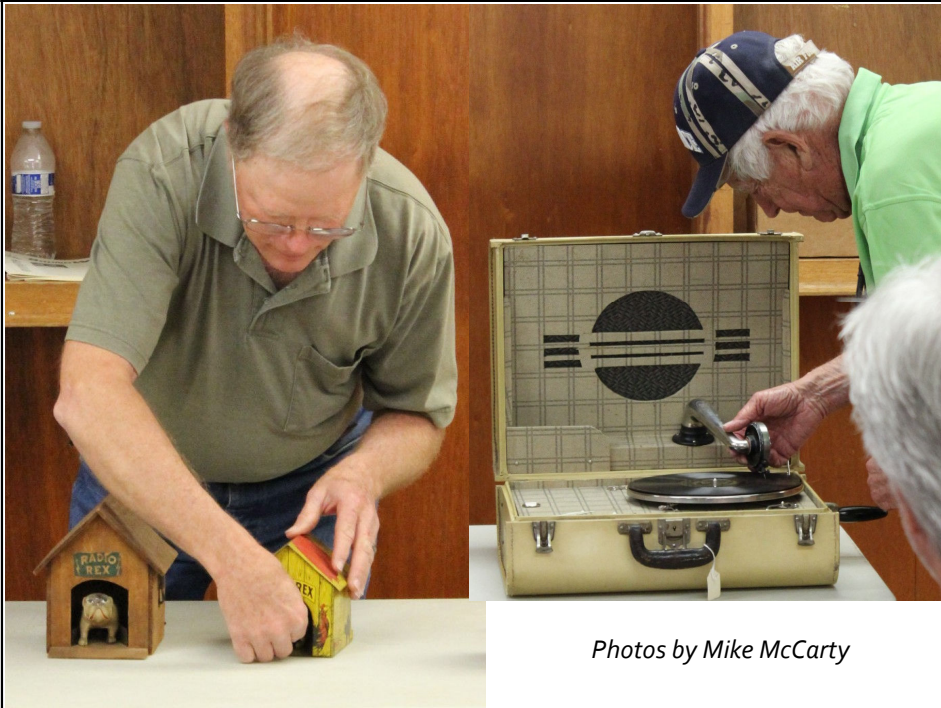
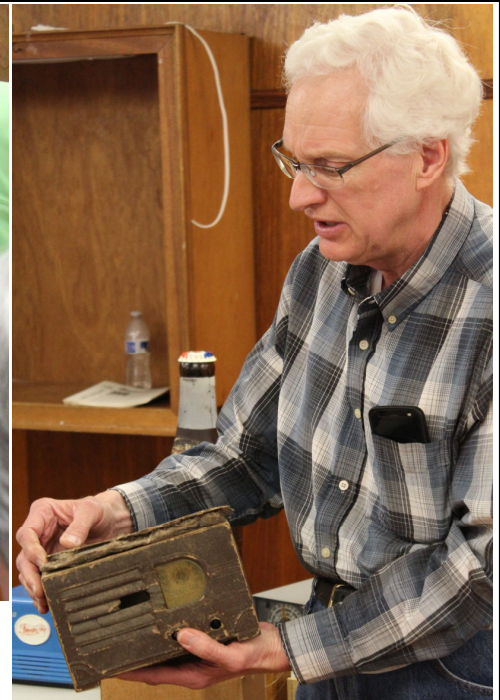
Photos by Mike McCarty

Billy Smith showed us a very unusual animated advertizing display device. He had restored it for another collector. It has the Crosley trade name on it and a phonograph turntable, but is not a phonograph! The turntable rotates much slower than a phonograph's. No one in the group had ever seen one before, and there was a lot of discussion and speculation as to its purpose. A popular opinion is that it was used to display a radio so as to let it to be seen from all sides. A "toaster" style

radio might be an example of one that a radio store might want to put in its window as an eye-catching moving display. Billy had cleaned it up thoroughly, put a new lamp in it and gotten it running.
