SOUND WAVES

VRPS Fall 2019

The Case of the One Station Wonder By Mike McCarty

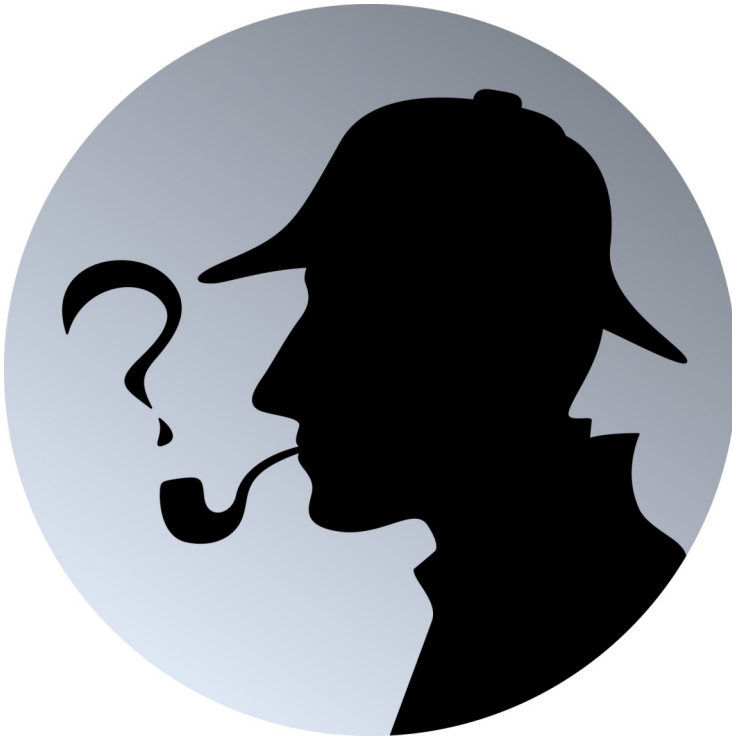
At the July 2019 Repair Session, a club member brought in the chassis of an Arvin Model 444 for me to look at. I asked him what the symptoms were, and he answered that he had recapped it, and replaced the out of tolerance resistors, but it only gets one station. For clarification I asked whether this one station was always received regardless of tuning, all across the band, and he replied that it had to be tuned in, but it's the only one the radio could receive. I tentatively classified this as "very low sensitivity, cause unknown". He then added that he had replaced the tuning condenser. I updated my estimate to "possibly caused by extreme tracking error or incompatible tuning condenser", and asked where he got the tuning condenser. He replied that he got it from an identical junker chassis, and I reduced the likelihood of the tuning condenser being the cause, but kept it in the back of my mind.

This radio has an antenna transformer, T1 in the schematic. [*Schematic on page 5*] The primary is connected to the antenna on one end, and to the chassis on the other end. The chassis is isolated from the power line through capacitor C4 in the schematic. It was very common in the past for this capacitor to fail shorted. If the antenna then came into contact with any ground, then the antenna transformer primary would be connected directly from the power line to ground. If that side of the power line happened to be "hot", then the primary of the antenna transformer would be burnt out, causing a tremendous loss of sensitivity, since the antenna would effectively be removed from the circuit. This was so common a situation in the past, that replacement primaries for antenna transformers were available in various sizes in order to repair this fault. I turned off the dim bulb, waited a moment for any voltages to dissipate, and then a quick check with an ohm meter showed that the primary was intact, shooting down that guess.

It was time to put on a different thinking cap. I measured the resistance between the oscillator grid (pin 5 of the 12SA7) and the AVC line. It was about 7 Meg. Looking at the schematic, I can trace from the oscillator grid, down through the grid leak (R4, 22,000 ohms) to ground, over and up through volume control (R7, 2 Meg), through the AVC filter resistor (R1, 4.7 Meg). OK, that looks normal. So, WHAT'S THE PROBLEM?

never even heard of one. However, I have come to the conclusion that I'm looking at a leaky mica capacitor, C6. It has to be. The AVC line is a very high impedance point, and even a small amount of leakage would overwhelm the intended drive from the volume control. I didn't bring any replacement capacitors suitable, and asking around didn't find any. This was so intriguing, that I decided to do the repair myself, rather than leave it up to the owner. I asked for and got permission to take the radio back with me to my work bench.

Later that afternoon, I went to stock and pulled out a suitable replacement, NPO ceramic capacitor. This capacitor is in a critical frequency determining circuit, and needs to be either a mica or an NPO ceramic. Morally convinced I had to be right, but still somewhat incredulous, and wondering if my diagnosis actually were correct, I unsoldered the original on one end, and tacked in the replacement. I hooked up my isolation transformer and dim bulb, and powered up the radio. After checking the bulb, I switched to full power, and the radio received stations all across the dial! I powered down the radio, finished removing the original leaky(!) mica, and did a proper job of soldering in the replacement. I powered on again with the dim bulb, then full power, and listened to the radio for about a half hour to verify that the repair was permanent. A leaky mica capacitor! Well, live and learn.
