SOUND WAVES

VRPS Summer 2020

Tips and Tangled Cords IF Transformers #1 Contributed by Blake Dietze

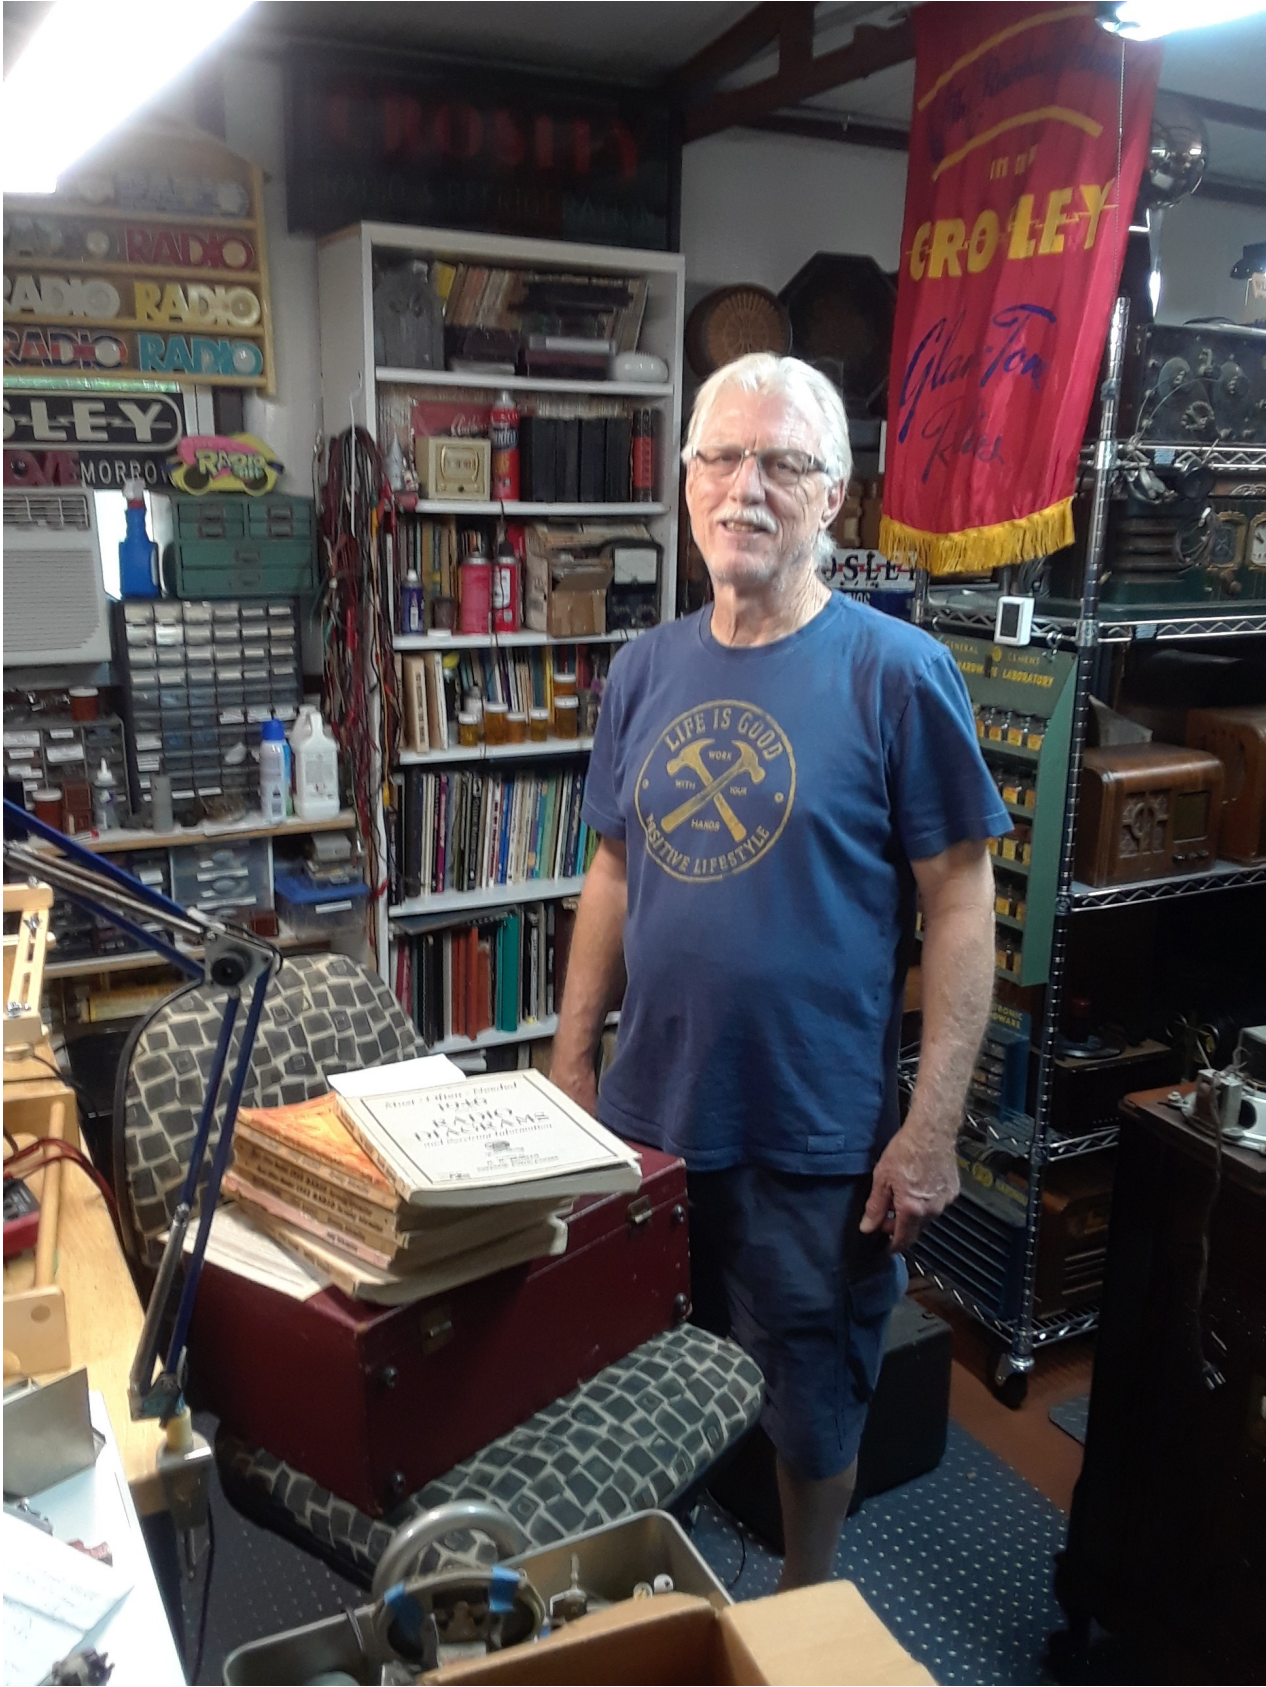
winding with a capacitor and resistor. If the primary is open, which is the most likely to fail since it's carrying high voltage to the plate of the previous tube, you can replace the open winding with a capacitor and resistor as shown in figure 1.

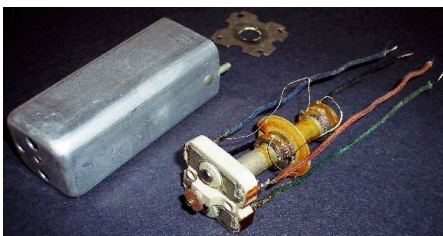
IF Transformers. When they work properly, they're fine. There are far too many failure cases to cover in just one column, so I'm going to divide them into multiple articles. In this installment I'm going to cover the IF coils found in superhetrodyne radios from the 1930's and 1940's. These are typically in metal cans mounted topside on the chassis and usually have screw adjustments on top or on the side.
