# SOUND WAVES

## VRPS Summer 2026

## July 18 Meeting Notes by Mike McCarty

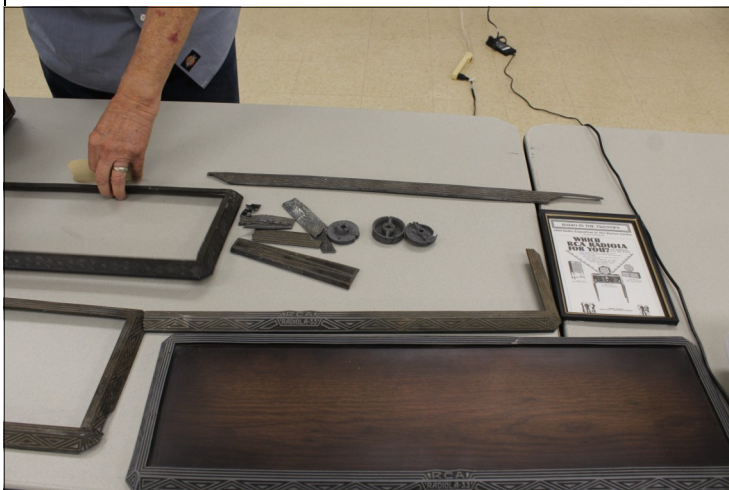
He displayed a special instrument he devised to straighten pot metal. He has a video showing how to use it. If the part breaks, superglue and baking soda make a great repair. (see photo below)

Larry Lindsey special tool for straightening pot metal.

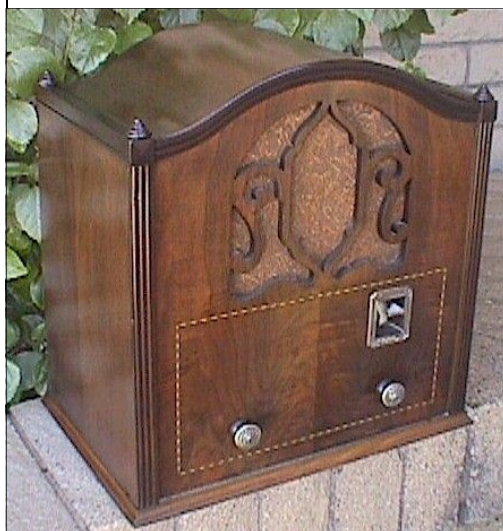
Majestic 50 from Radio Attic Archives

Jim Brownlee brought in a Majestic model 50 Tombstone style radio in as-found condition to get advice on how to start repairing it. No service literature was available for that radio at the meeting. Jim Sargent was the "expert" in charge of this one. cursory examination showed that the power transformer likely had some damage due to heat, because some of the high melting wax (which looks like tar) used in them had melted and oozed out. This can be caused by shorted turns in the transformer windings, requiring replacement of the transformer. Many of the capacitors (paper and electrolytic) were in potted cans filled with similar high melting wax. All paper and electrolytic capacitors must be replaced, but the ones in potted cans present a special challenge, due to the necessity of removing the potting wax. Jim advised Tim that this is not a suitable radio for a beginner to attempt repairing, and arranged that John Dusek should do the repair for Tim.

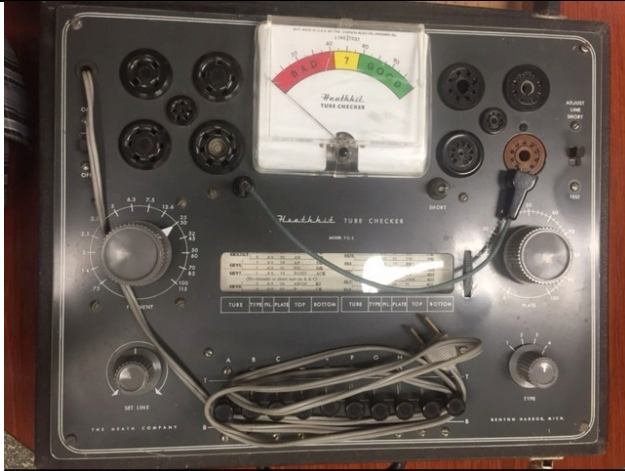
Diana Cangelosi brought in a Heathkit TC-2 tube checker. Tube checkers usually have an adjustment to account for variations in AC power line voltage variations, and this one is no exception. However, no matter how the "Set Line" adjustment was varied, the meter pointer could not be made to rest at the required location, but only below it. Mark Blackwood rose to the occasion. He opened the case, and immediately noticed there was an old, original paper capacitor remaining in the circuit. He replace it with

Heathkit TC2 from Rex and the Bass Memory Lane

First, he verified the reported symptom. Indeed, the "Line Adjust" could be used to move the needle around near 1/4 of full scale at most, but the adjustment was supposed to put it at 1/2 of full scale. The way this works is that

there is a wire wound rheostat in parallel with a portion of the primary of the power transformer. It is used to adjust for variations in line voltage, so the voltages on the secondary windings are always the same. There is a nominally 100 VAC winding in the secondary which has two resistors across it to select a portion of it. These feed a selenium (Se) rectifier, which then supplies pulsing DC current to the 1 mA movement. The next step was to test the resistors.

Vintage resistors are notorious for increasing in value. Mike unsoldered some wires to eliminate interference from other components in parallel, and verified that the resistors were within tolerance. This eliminated the resistors as a source. Next, the 110 VAC secondary of the power transformer was checked. It was providing 109.3 VAC, which is "spot on". That left the meter and the Se rectifier as candidates for the cause.

Mike borrowed a digital meter capable of measuring current from Jim Sargent (thanks Jim!) and put it in series with the meter in the TC-2. In this way, the current in both would be exactly the same. He turned on the power, and measured the actual current flowing through the two meters. The TC-2 meter indeed showed approximately 1/2 of the current the digital meter showed.

Unfortunately, the magnets in some of these meters are known to lose strength over time, so that the magnetic force is reduced, causing the meter to read "low". That is very likely the cause of the problem with the TC-2. Jim Sargent came by to see how things were progressing, and was told of the diagnosis of a weak meter magnet, and volunteered the information that he had some meters that could be used to repair the TC-2, though they would be cosmetically different.

a modern compatible component. Although this repair needed to be done because vintage paper capacitors are notoriously always bad, this did not resolve the problem, because that capacitor is used only for the shorts test which does not involve the meter.

correct. Mike checked the knob on the heater voltage setting control switch, and found that it was loose on the shaft and was not correctly aligned with the markings. After repositioning the knob on the shaft and tightening the set screw, Mike checked the voltages on the heater pins of one of the sockets, and verified that the heater voltages were now correct on all settings. Presumably, although the knob was pointing to the 6.3 volt mark, the shaft was positioned on a much larger voltage.

A lesson to be learned is: after repairing vintage equipment, always fully check it for proper operation before using it. For example, often people use a so-called dim bulb when first testing a repaired radio. Mike recommends doing so with a bulb rated about twice the necessary power for the radio, and letting it run like that for a hour before trusting it for use without a limiter like a dim bulb.

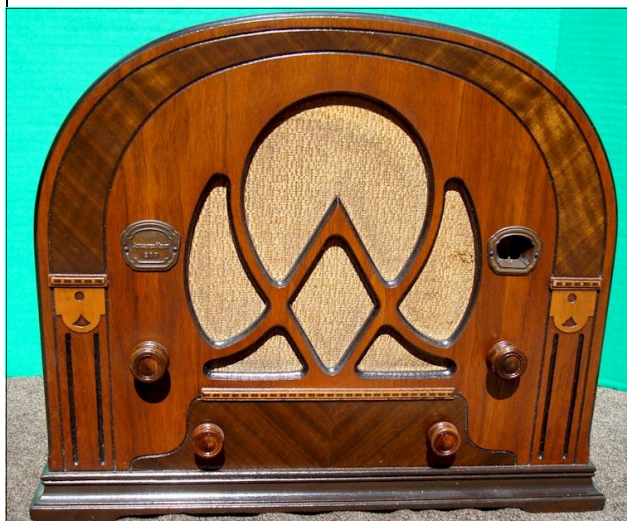
Atwater Kent 217 from Radio Attic Archives

Mitch Staab brought in an Atwater Kent model 217 for investigation. The symptoms were no reception, though all tubes had supposedly tested good. Some preliminary capacitor replacement had been done. Roland Gooch took up the challenge. Injection of audio into the volume control resulted in weak sound; presumably there is a problem in the audio amplifier (AF amp), but that does not explain the no reception at all.

Concerning the AF amp, all easily tested components were tested and found to be good. Possibly the AF tubes, though tested good on a tube checker, actually cannot amplify adequately, or the speaker or output transformer has a problem.

Injecting a signal at the intermediate frequency (IF) into the antenna terminal resulted in strong output from the IF amplifier, indicating that it was performing adequately, and that the mixer was capable of amplifying at the IF, suggesting that the local oscillator (LO) might have a problem.

Roland performed a commonly used test for operation of the LO by measuring the voltage on the LO grid. The voltage was -0.2 volts, indicating that the LO was not working. Normally, the LO derives the voltage on the grid by rectifying its own signal, resulting in a grid voltage usually between -5 volts and -12 volts. All coils in the radio frequency (RF) portion of the circuit were checked for continuity and reasonable resistance, and all seemed to be ok. The plate load resistor in the LO circuit, nominally 15 K ohms, was found to be 33 K ohms, which is out of tolerance and bad. However, experience tells us that while this might result in a weak LO signal, it should not kill the LO altogether.

So, the lack of performance in this set is still something of a mystery. The path forward is to replace the LO plate load resistor and audio tubes with some known to be good, and continue diagnostic efforts.
